SUMMARY REPORT

Assured Home Inspections

Document #: 0801122

Dwelling Address: 123 Anywhere Avenue, Somewhereville, Alberta

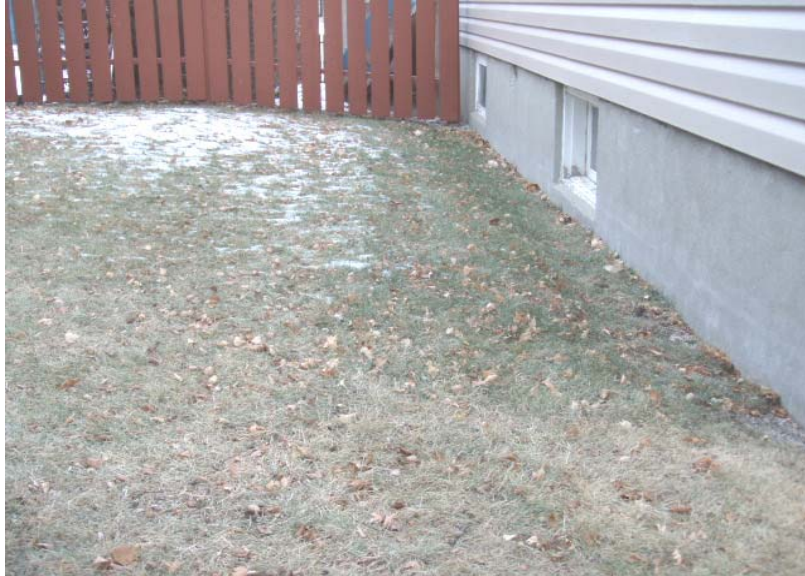
1102. Grade, Slope and Drainage

Maintenance. Low areas noted at various locations around the foundation. Recommend adding backfill or regrading as necessary, to ensure proper, positive drainage away from the foundation/structure at all times. Recommend further review by a qualified specialist for repair estimate prior to closing.

Step #	Component	Comments
1101	Lot	Functional. Residential.
1102	Grade/Slope/Drainage	Maintenance. Minor slope; Low Area(s) Noted; Surface drainage system noted. Low areas noted at various locations around the foundation. Recommend adding backfill or regrading as necessary, to ensure proper, positive drainage away from the foundation/structure at all times. Recommend further review by a qualified specialist for repair estimate prior to closing. Surface drainage system noted. It is beyond the scope of this inspection to perform tests on surface drainage systems; suggest client obtain information from seller or verify that the drainage system functions properly prior to close.
1103	Driveway	Functional. Asphalt over concrete. Common cracks noted.
1104	Walkways	Functional. Textured/Sculpted concrete.
1105	Patio	Functional. Patio blocks.
1106	Retaining Wall(s)	Attention. Wood. Wood deterioration/rot observed. In the Inspectors opinion, the retaining wall(s) are at/near the end of their serviceable life. Recommend further review by a qualified specialist for repair/replacement estimate prior to closing.

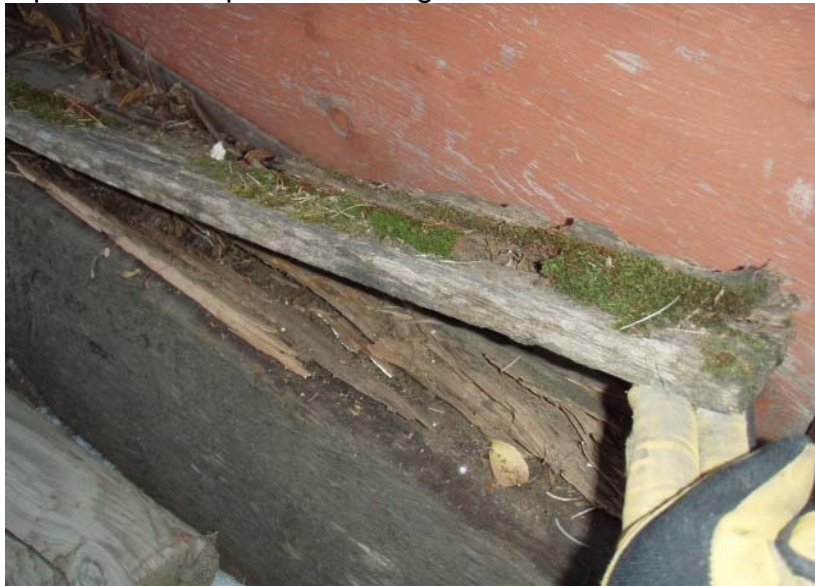
1106. Retaining Wall(s)

Attention. Wood deterioration/rot observed. In the Inspectors opinion, the retaining wall(s) are at/near the end of their serviceable life. Recommend further review by a qualified specialist for repair/replacement estimate prior to closing.

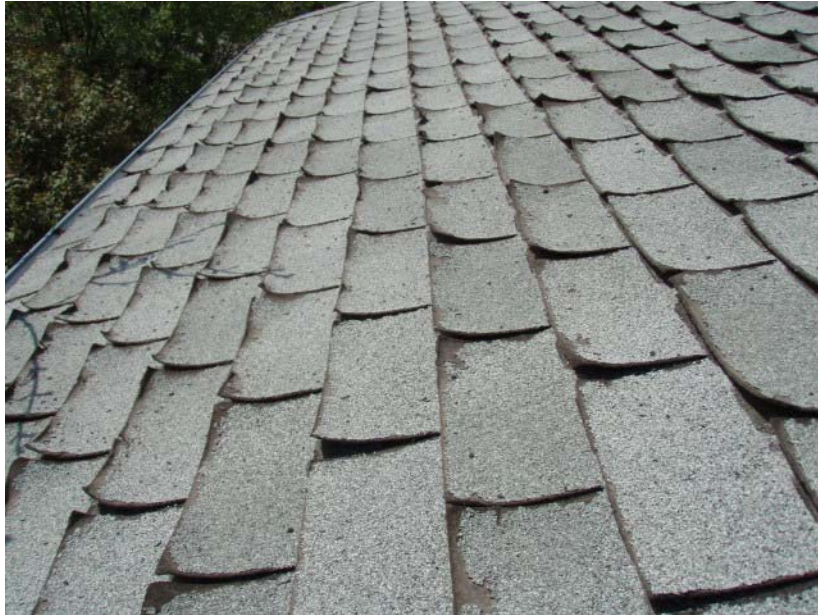
1203. Conditions and Observations

Attention. Following conditions were noted: Granular loss, cracking and curling shingles, most notably on the southern exposure. In the Inspectors opinion, these roofing materials are at the end of their serviceable life. Recommend review by a qualified professional for repair/replacement estimate, as necessary, prior to close.

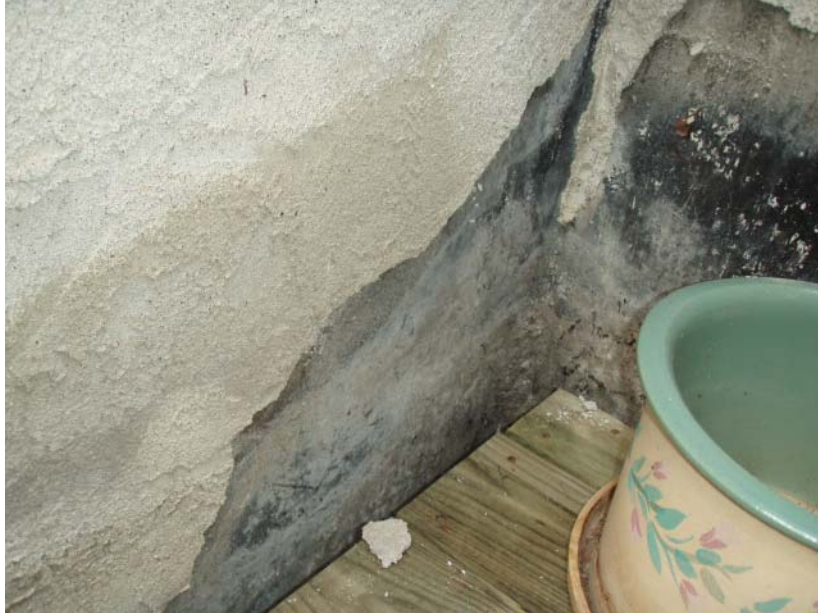
1400. Foundation
and Coating

Maintenance. Common cracks noted. Loose/missing parging observed, suggest reparging where required as part of routine maintenance.

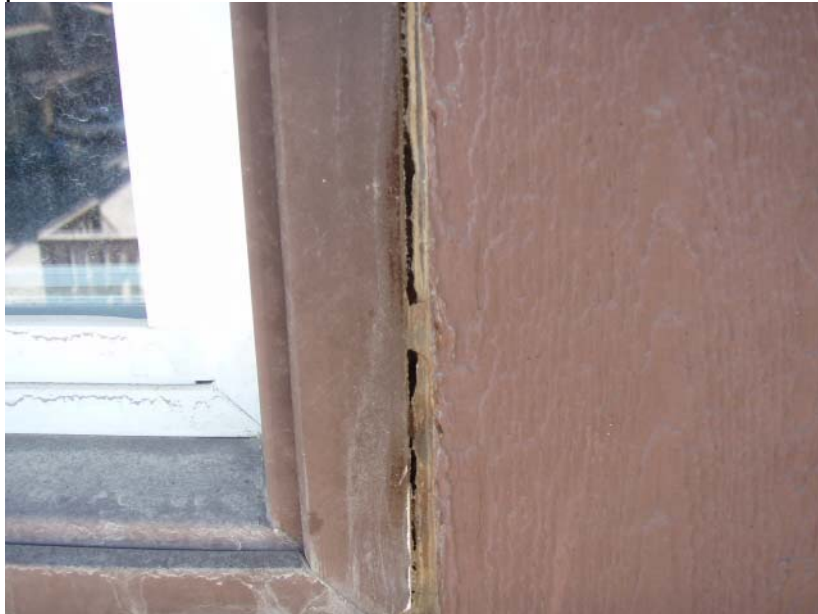
1402. Trim

Maintenance. Recommend sealing/caulking where required as part of routine maintenance.

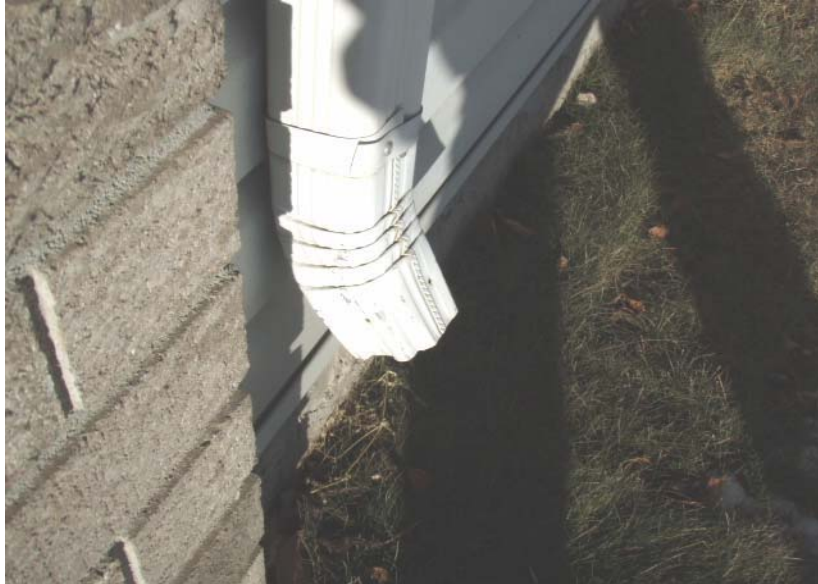
1404. Downspouts and Extensions

Maintenance. Missing downspout extension(s) noted, recommend replacing these to ensure proper drainage away from the foundation.

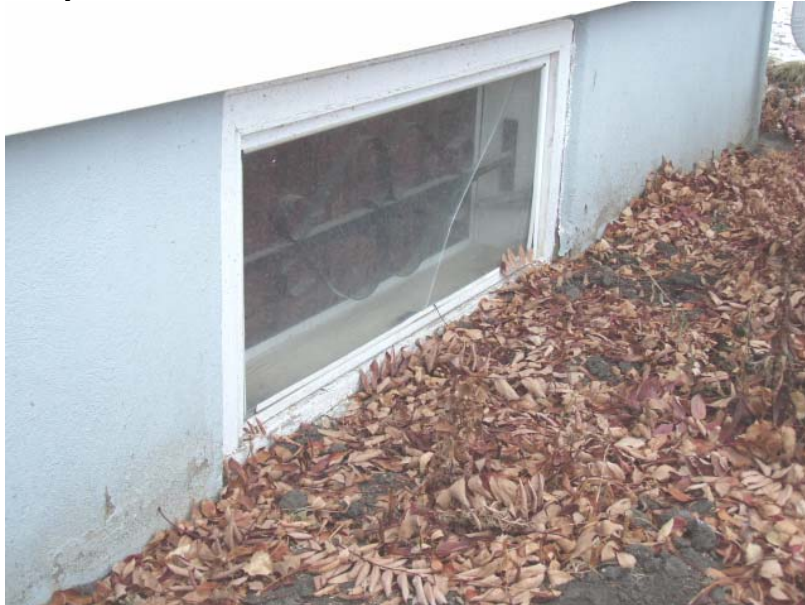
1405. Windows and Frames

Attention. Cracked window pane(s) observed, recommend repairs. It would appear that some of the basement windows are at/near grade. Recommend regrading or having windows wells installed to prevent seepage at these locations. Recommend further review by a qualified specialist for repair estimate prior to close.

1405		<p>Attention. Wood Frame; Metal Frame; Synthetic Frame; Aluminum Cladding; Window Wells; Thermopane. Cracked window pane(s) observed, recommend repairs. It would appear that some of the basement windows are at/near grade. Recommend regrading or having windows wells installed to prevent seepage at these locations. Recommend further review by a qualified specialist for repair estimate prior to close.</p> <p>Thermopane windows (some or all windows) observed in the dwelling. Thermopane windows have a seal between the panes for efficiency. Over time these seals can fail. This is usually indicated by condensation between the glass panes. Generally, this condition shows itself when there are colder outside temperatures. For more complete information on the condition of all double glazed windows, we recommend consulting the seller prior to closing. Window wells should be cleaned out regularly to promote proper drainage.</p>

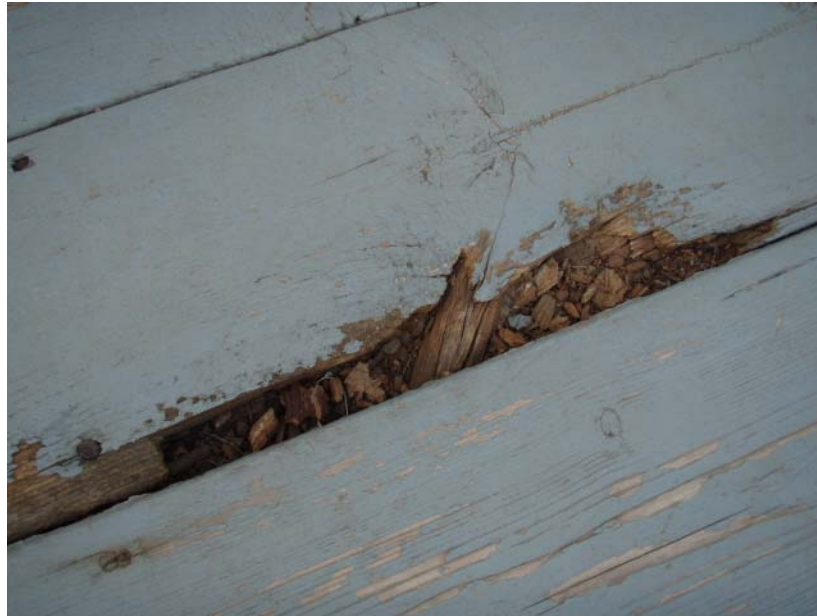
1408. Deck(s)

Attention. Wood deterioration/rot observed on many of the deck boards. Recommend further review by a qualified professional for repair/replacement estimate prior to close.

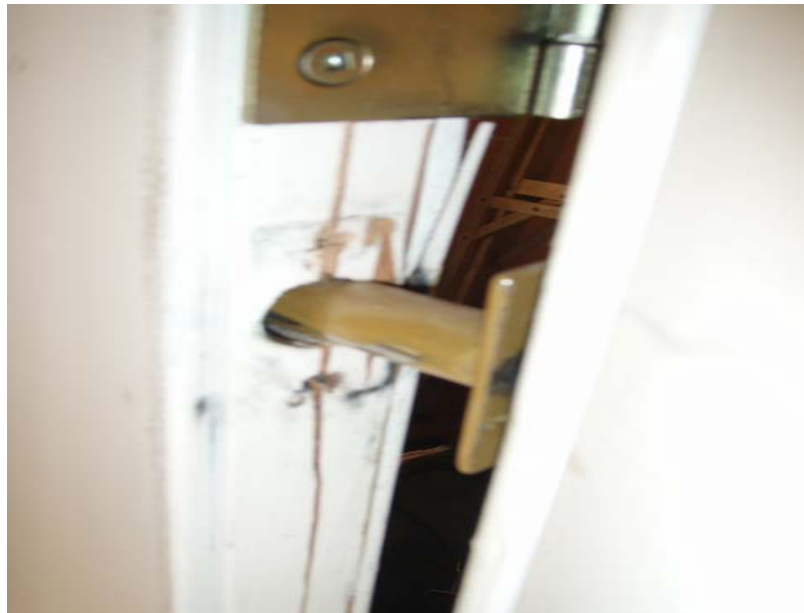
1606. Fire Door

Attention. Damaged door and self closing device. It is required that the door between the garage and dwelling be fitted with a self-closing device. Recommend further review by a qualified professional for repairs estimate prior to close.

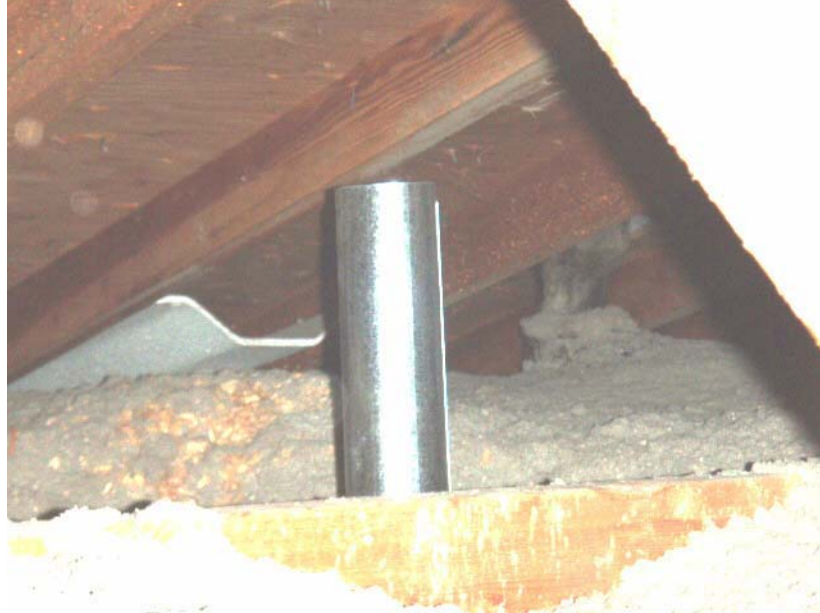
2105. Ventilation

Attention. Exhaust fan(s) appears to be vented into attic space. Exhaust fan(s) are required to be vented through the roof, with insulated ducting, to a proper and dedicated roof vent. This is to prevent moisture/condensation from occurring and subsequent damage in the attic area. Recommend further review from a qualified professional for repair estimate prior to close.

2105	Ventilation	Attention. Hooded Roof Vents; Soffit Vents. Exhaust fan(s) appears to be vented into attic space. Exhaust fan(s) are required to be vented through the roof, with insulated ducting, to a proper and dedicated roof vent. This is to prevent moisture/condensation from occurring and subsequent damage in the attic area. Recommend further review from a qualified professional for repair estimate prior to close.
2106	Electrical	N/A. None. No electrical equipment was observed in the attic space.

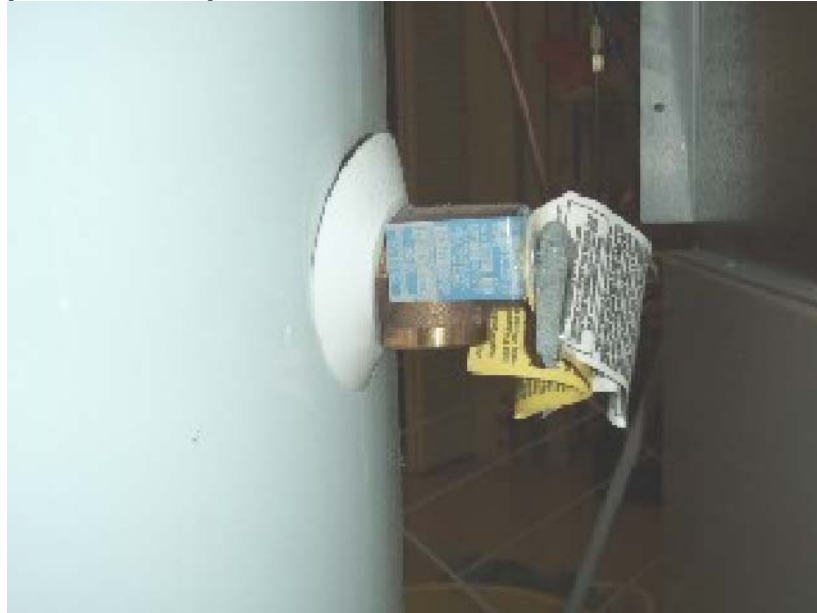
2301. Tank

Attention. The water heater appears to be 22 years of age. Average life expectancy is 12-15 years. Recommend replacing this unit. Recommend obtaining replacement estimate from a qualified professional prior to close.

TPR valve discharge pipe is missing; recommend having this inexpensive but essential copper pipe installed for safety.

Step #	Component	Comments
2300	Fuel Supply	Functional. Natural Gas.
2301	Tank	Attention. 33 gallon/151 litre (approx.). The water heater appears to be 22 years of age. Average life expectancy is 12-15 years. Recommend replacing this unit. Recommend obtaining replacement estimate from a qualified professional prior to close. TPR valve discharge pipe is missing; recommend having this inexpensive but essential copper pipe installed for safety.
2302	Combustion Chamber	Functional. Partially visible.

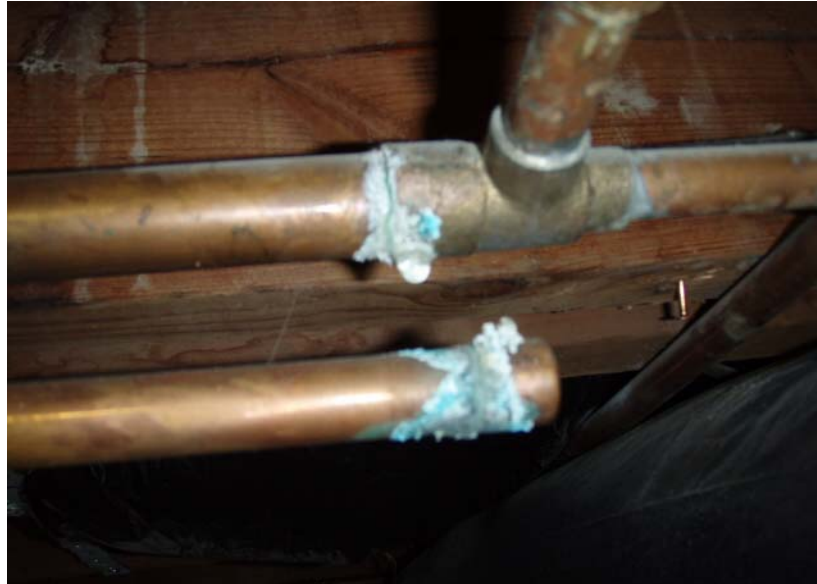
2502. Supply Piping

Attention. Leakage observed at copper supply piping, visible in the laundry room. Recommend further review by a qualified professional for repair estimate prior to close.

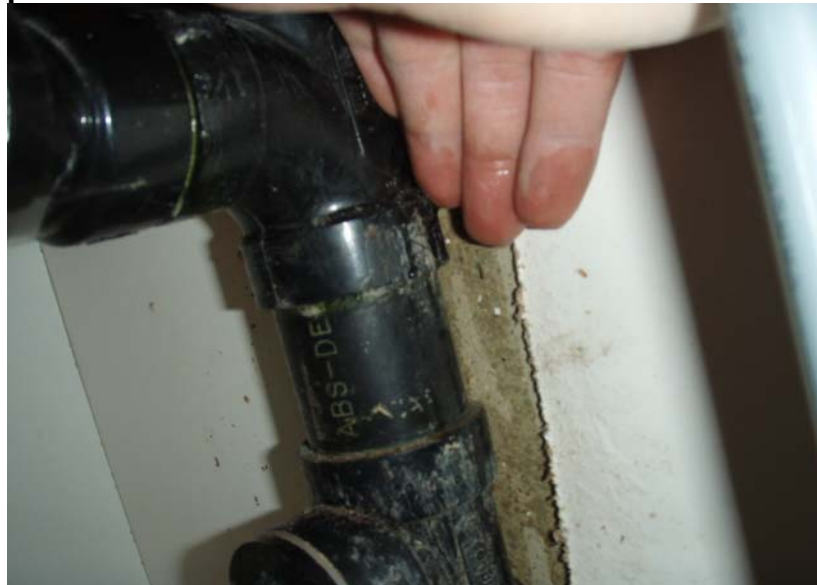
2504. Drainage Piping

Attention. Leakage observed at ABS drain piping, visible in the furnace room. Recommend further review by a qualified professional for repair estimate prior to close.

2503	Waste Removal	Functional. Most of the components in a public waste system are not accessible to the inspector (ex: underground pipes) and are not within the scope of this inspection.
2504	Drainage Piping	Attention. ABS plastic. Leakage observed at ABS drain piping, visible in the furnace room. Recommend further review by a qualified professional for repair estimate prior to close. Some sections of the drainage piping is located behind finished/partially finished, concealed/partially concealed walls or ceilings. Concealed/finished components were not inspected as they are not accessible or visible to the inspector.

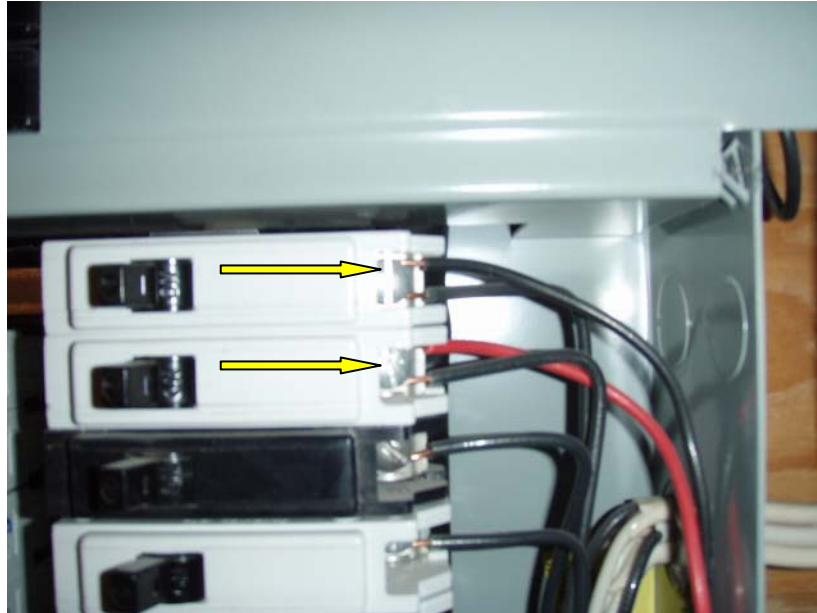
2601. Main Electrical
Panel

Attention. Double lugging (double tapping) noted. This is where two wires are connected to one breaker, which is not allowed. Recommend further review by a qualified professional for repair estimate prior to close.

Step #	Component	Comments
2600	Main Electrical Service Drop	Functional. Overhead Service; Rear Located Meter.
2601	Main Electrical Panel and/or Sub-electrical Panel	Attention. Breakers; 100 amp; Grounded; Copper service to panel; Double tapping. Double lugging (double tapping) noted. This is where two wires are connected to one breaker, which is not allowed. Recommend further review by a qualified professional for repair estimate prior to close.
2602	General Wiring	Functional. Copper Branch Circuitry; Non-metallic Sheathed Cable; 120 volt & 240 volt Branch Circuitry; Upgraded 2 Wire System. Some sections of the branch circuitry of this system utilizes a 2 wire system, where there is only hot and neutral wires; no ground wire. This type of wiring system was common in older (pre 1960) homes. As part of an electrical upgrade, it would appear that this system has been upgraded and GFCI protected (deadfronted), as applicable.

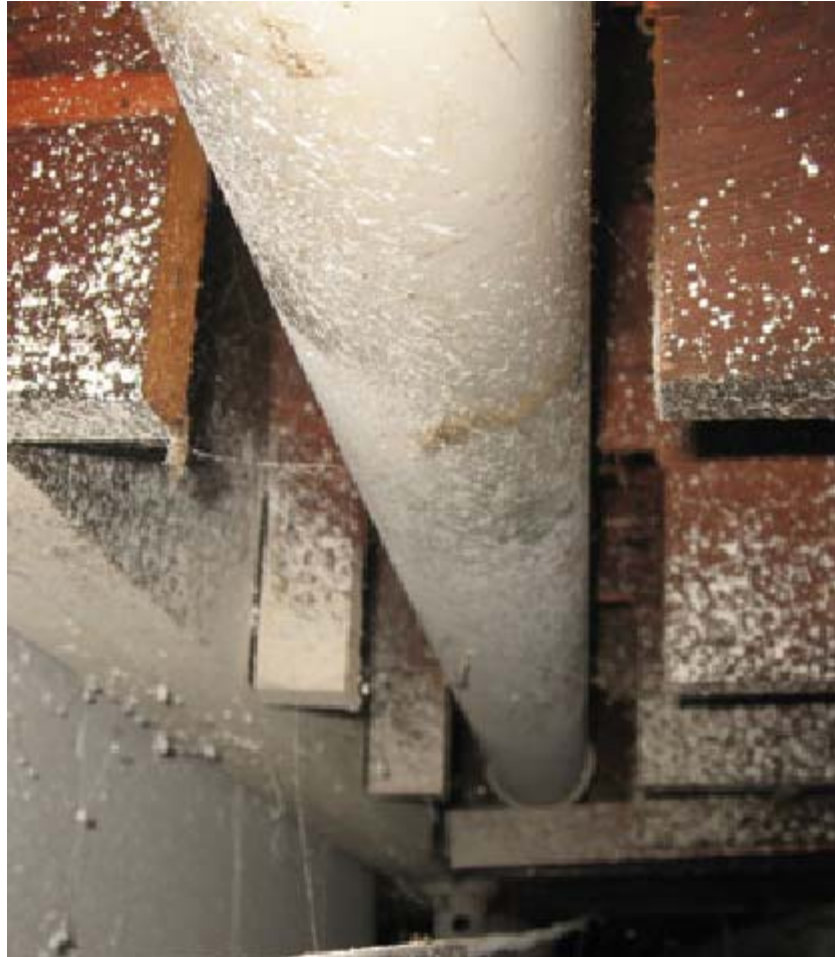
2708. Floor Joists

Attention. Improper notching of joist observed. Notches are to be located on the top of the member within 1/2 the joist depth from the edge of bearing and are not to be deeper than 1/3 the joist depth unless depth of member is increased by the size of the notch. Recommend further review by a qualified professional (with structural expertise) and obtaining a repair estimate prior to close.

2708	Floor Joists	Attention. 2x10 Dimensional Lumber; Concealed. Improper notching of joist observed. Notches are to be located on the top of the member within 1/2 the joist depth from the edge of bearing and are not to be deeper than 1/3 the joist depth unless depth of member is increased by the size of the notch. Recommend further review by a qualified professional (with structural expertise) and obtaining a repair estimate prior to close. Joists are finished/partially finished, concealed/partially concealed. Concealed/finished components were not inspected as they are not accessible or visible to the inspector.
2709	Subfloor	Functional. Wood Plank; Concealed. Subfloor is concealed/partially concealed. Concealed/finished components were not inspected as they are not accessible or visible to the inspector.
2710	Framing	Functional. 2x4 Wood. Review of the actual and overall 2x4 framing is limited as it is mostly, if not entirely, concealed by finished walls (exterior and interior). Problems with the actual framing can only be discovered by "invasive" inspection, which is not allowed and beyond the scope of a home inspection.

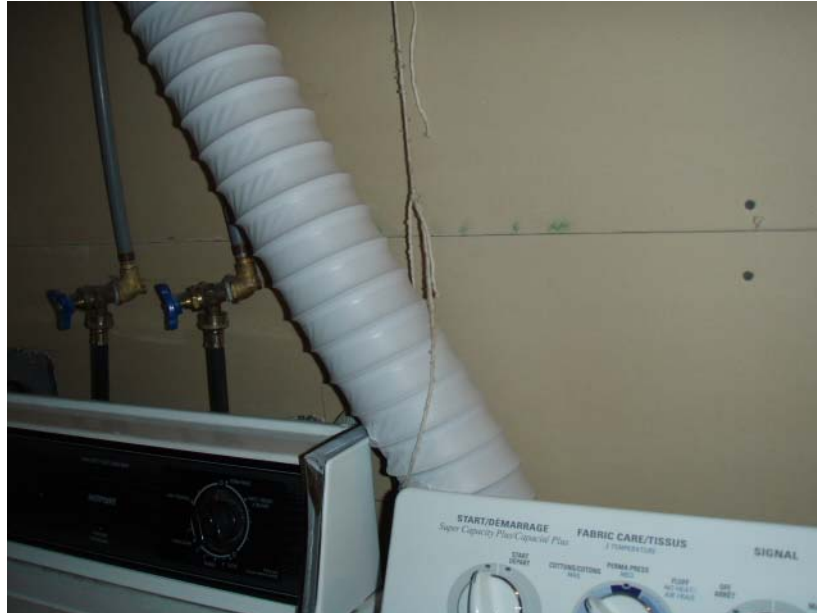
2913. Dryer and Hook-ups.

Attention. Flex-vinyl venting is no longer approved for dryers and should be replaced with an approved type of dryer vent piping.

2910	Heat Source	Functional. Register.
2911	Tub/Sink/Faucet/Drain	N/A. None.
2912	Washer/Hook-ups	Functional. Hot & Cold Water Supply; Drain Piping. Washing machine was operable at time of inspection.
2913	Dryer/Hook-ups.	Attention. Vent; Gas & 240 volt Electric. Flex-vinyl venting is no longer approved for dryers and should be replaced with an approved type of dryer vent piping. Dryer was operable at time of inspection.

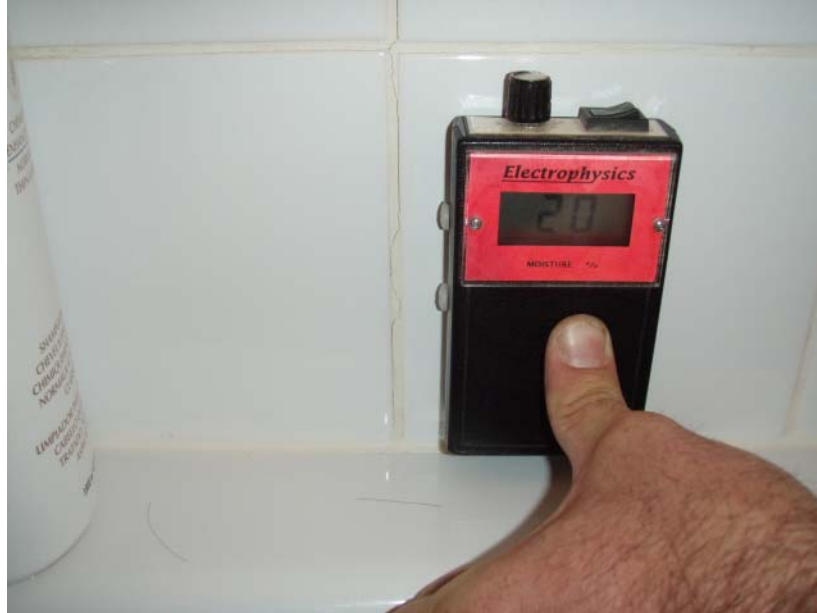
3116. Tub Surround

Attention. Loose/cracked/missing grout observed at many areas. Soft walls noted at many areas. This is an indication of moisture penetration and damage. Moisture meter showed a reading of 20%. Recommend further review by a qualified professional for repair/replacement estimate prior to close. All tub/shower walls should be routinely caulked/sealed to prevent moisture penetration and subsequent damage. All missing/damaged/cracked grout should be repaired/replaced. An approved grout sealant should be applied annually. Failure to keep walls sealed can cause deterioration and extensive moisture damage to the framing, flooring, and surrounding walls. This damage is not always visible or accessible to the inspector at time of inspection.

3116	Tub Surround	Attention. Tile. Loose/cracked/missing grout observed at many areas. Soft walls noted at many areas. This is an indication of moisture penetration and damage. Moisture meter showed a reading of 20%. Recommend further review by a qualified professional for repair/replacement estimate prior to close. All tub/shower walls should be routinely caulked/sealed to prevent moisture penetration and subsequent damage. All missing/damaged/cracked grout should be repaired/replaced. An approved grout sealant should be applied annually. Failure to keep walls sealed can cause deterioration and extensive moisture damage to the framing, flooring, and surrounding walls. This damage is not always visible or accessible to the inspector at time of inspection.
3117	Tub Enclosure	Functional. Curtain/rod.
3118	Tub Faucet/Tapset	Functional. Double Lever.
3119	Shower Head	Functional. Standard.

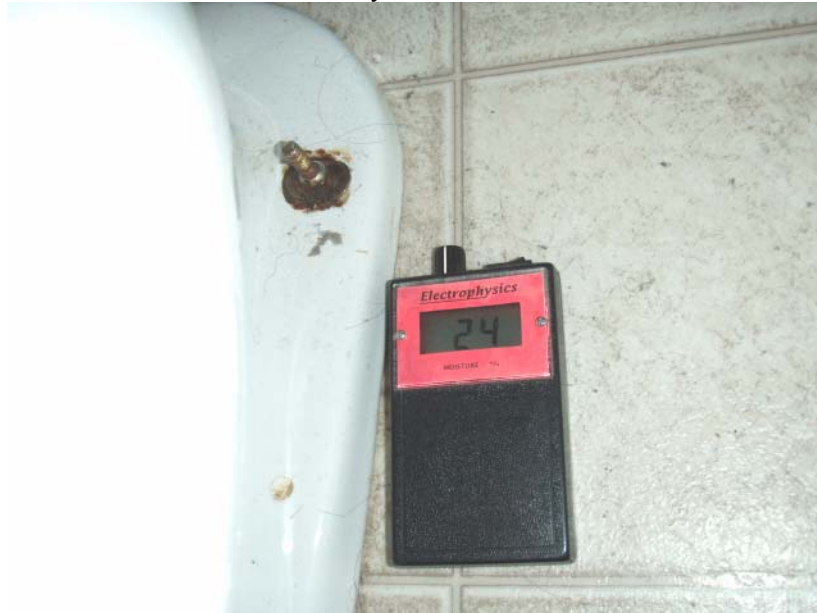
3414. Toilet

Attention. Loose toilet observed. Moisture meter has detected significant moisture (24%) under the flooring, which indicates moisture penetration and possible damage to the subfloor. This condition is not fully visible or accessible to the Inspector without destructive investigation. Recommend further review by a qualified professional for repairs estimate prior to close.

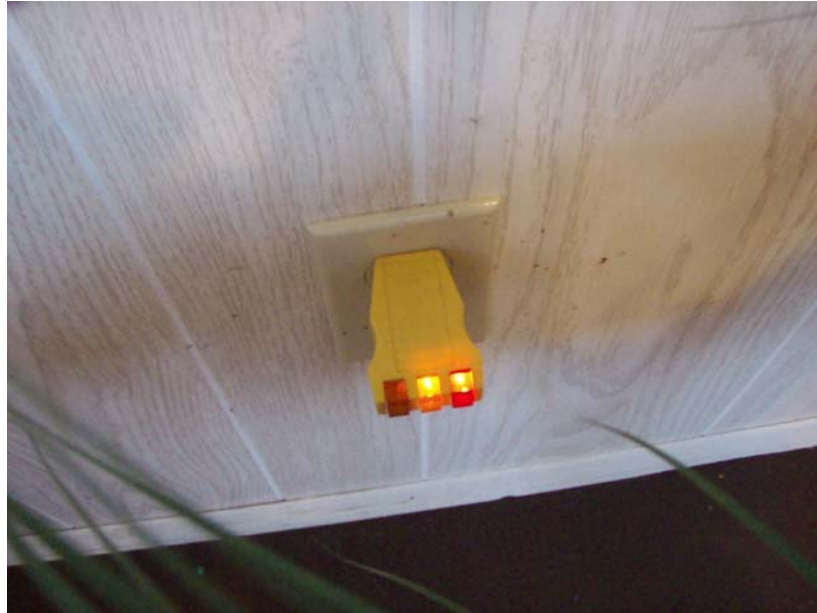
3608. Electrical

Attention. Reversed polarity receptacle(s) observed. This means that the hot and neutral wires have been installed incorrectly, on the wrong sides of the receptacle. Recommend minor repairs to have this corrected.

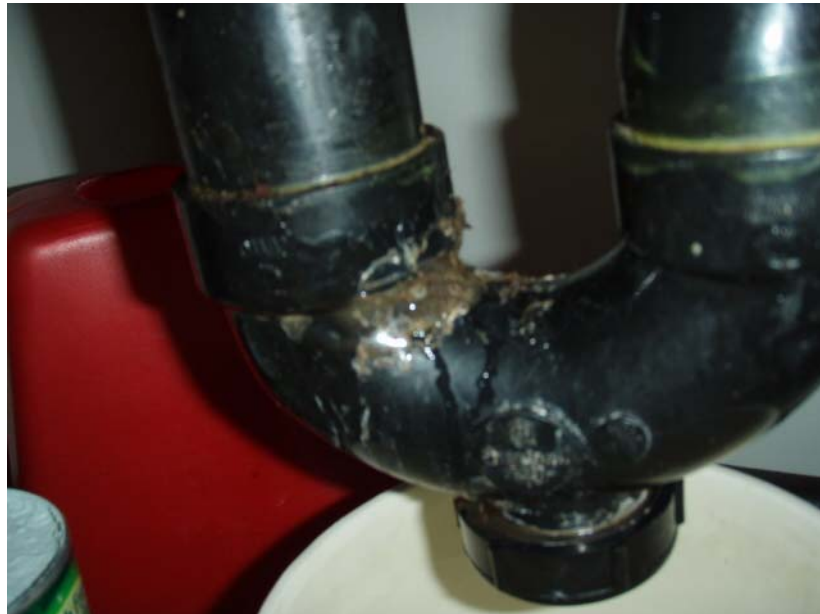
4613. Drain/Trap

Attention. Leakage observed at drain piping. Recommend further review by a qualified professional for repair estimate prior to close.
